The new White Tower staircase, Tower of London

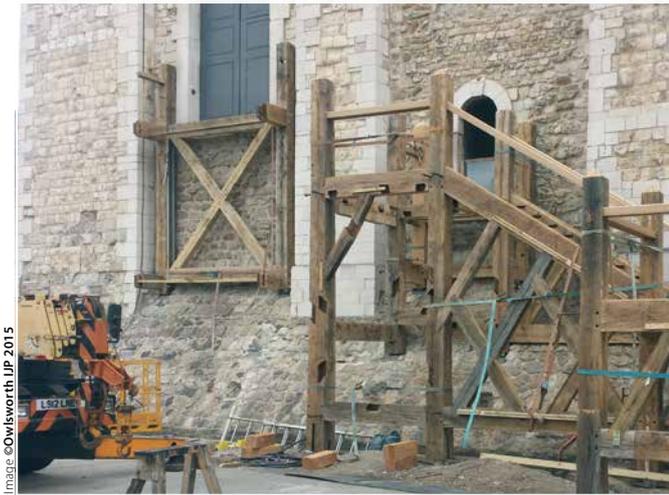
The angled batter in this section was discovered to be of the original 11th century fabric. Consequently postholes from the previous staircase could not be enlarged as planned. A design change incorporating metal shoes overcame this obstacle.

Once the previous staircase was removed early in 2014, the post-holes created during the 1970's installation could be investigated. These had to be reused with minimal disturbance to the fabric of the building and its archaeology. However, given the greater size and dimensions of the new staircase, the post-holes in the battered plinth of the White Tower were investigated to see if they could be enlarged.

This work was done under close archaeological supervision as there was a risk of disturbance to the Norman stonework surrounding the post-holes. The investigations

confirmed this stonework as a part of the original 11th century fabric. In the light of this discovery and once everything was carefully recorded, it was decided not to enlarge the post-holes and an

alternative was designed. This was a challenge for the architect and structural engineer at a point in the project when the staircase was already in production. After much head-scratching, a solution was devised which safe-guarded the historic fabric, whilst making sure that the staircase was structurally sound. The solution involved shaping the bottoms of each post to

fit the existing holes together with stainless steel armatures inserted inside the post feet. These sat on an adjustable shoe, resin-set into the existing pockethole. This took a considerable amount of time to execute and even involved the fabrication of full size polystyrene mock-ups of each post foot.

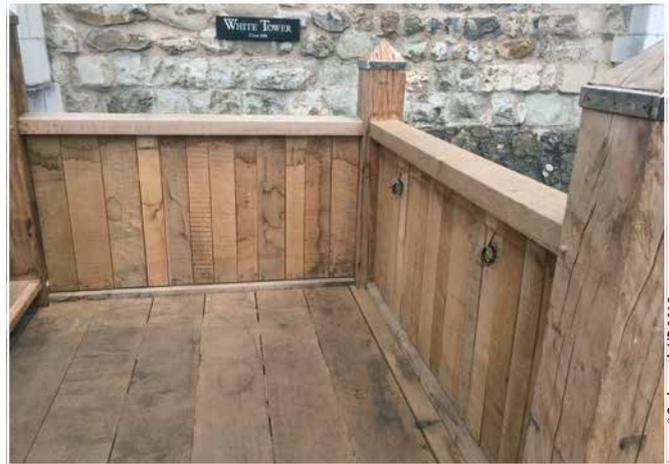
The lower landing showing the quarter sawn oak boards of the balustrade.

The planking for the balustrade would most likely to have been riven in the Norman period, as pit sawing was not generally practiced but would have been impractical in our case. We therefore compromised by using boards quarter sawn from standing dead trees which were already partially dry, reducing shrinkage problems. Our band mill also has the 'advantage', of cutting at an angle rather less than perpendicular to the timber's edge, producing a surface which looks a fair substitute for a pit-saw cut.

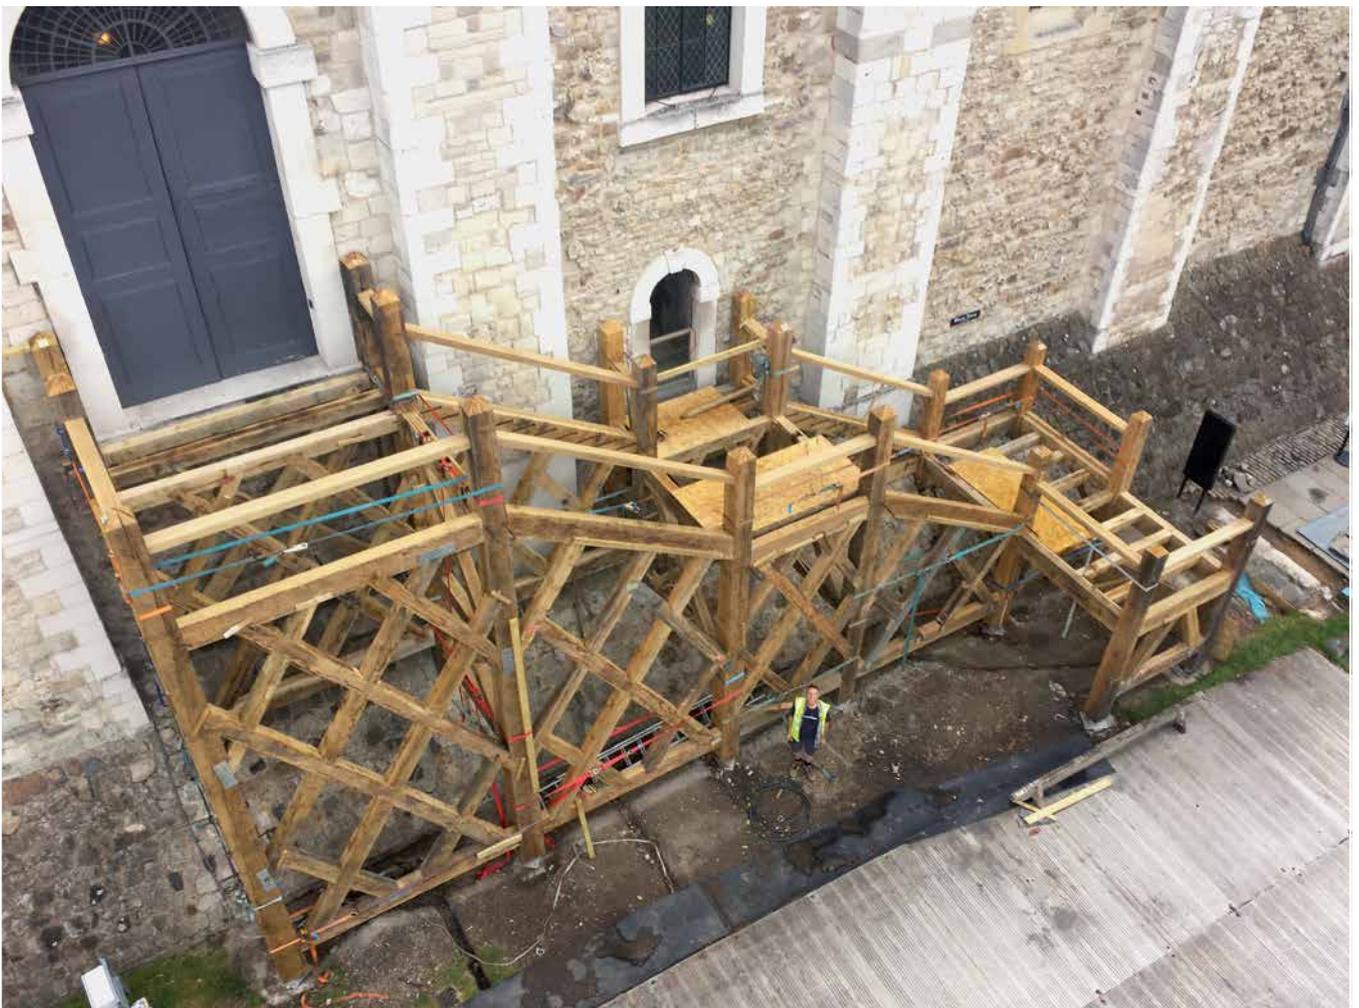
A crane's eye view after most of the principal raising had been completed.

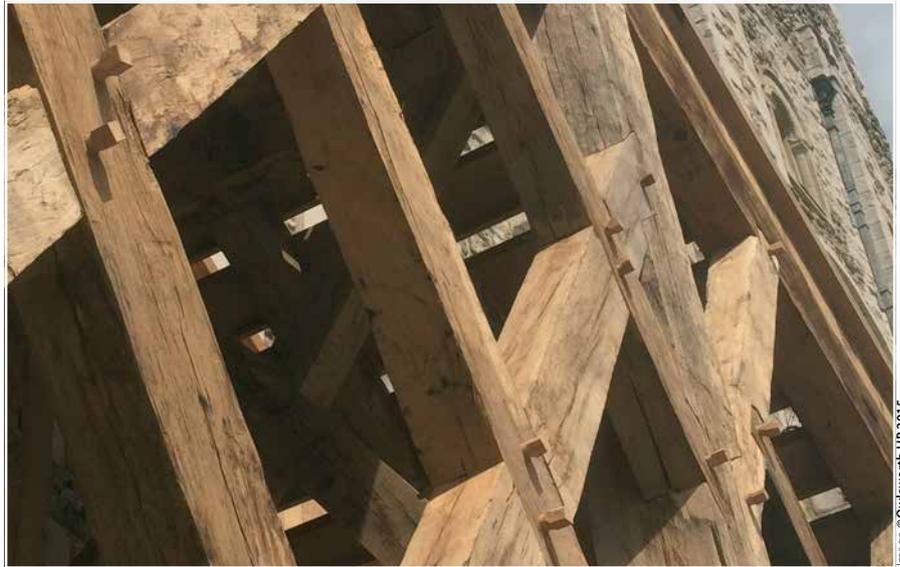
Engineering considerations required metal fixings for the halving joints. False wooden peg ends were made to fit over the fixings so as not to distract from the hewn finish.
