BUILDING MATERIALS FOR PERIOD PROPERTIES: THE IMPORTANCE OF LIME

Written by Robin Dukes, Managing Director, Owlsworth IJP Ltd

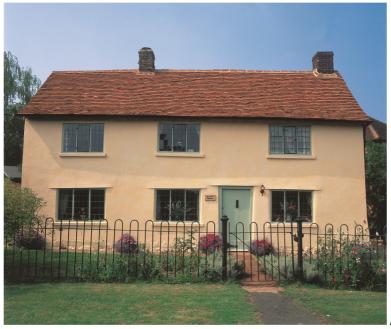
A lime rendered witchert (cob) house

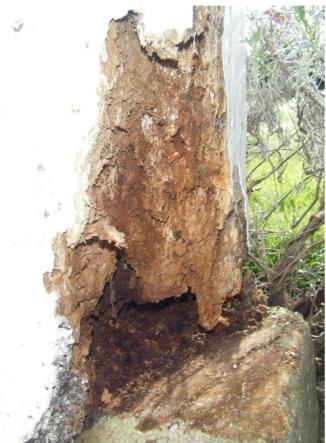
Cement damage to a structural timber frame

In timber framed buildings we often see the infill panels within the frame rendered with a cement render and painted with modern masonry paint. Here the timbers are left highly vulnerable to the effects of wet rot and insect attack. Numerous timber frames have suffered from the introduction of modern impervious materials, which tend to channel water in and around the timbers, and so over time can cause major timber decay and structural issues. Rainwater that runs down a wall repaired using lime mortars and renders is drawn into the surface evenly and, due to their porosity, is allowed to escape unhindered.

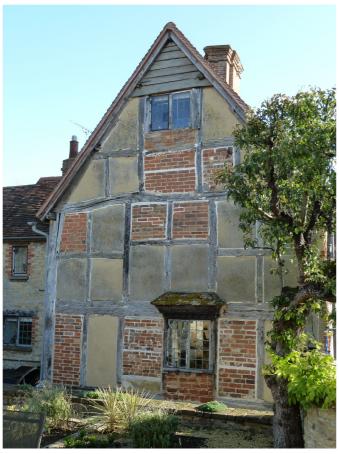
Damage by a cement render

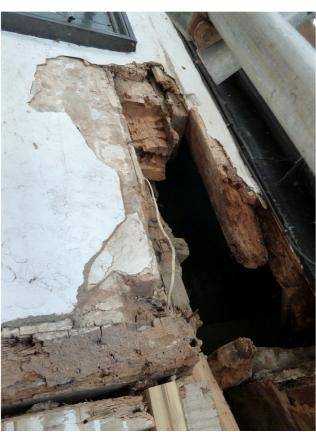
Damp damage caused by a cement render
